Aerial Photograph Anomaly 44

Aerial Photograph Anomaly Program
Marine Corps Air Station, El Toro, California

3 November 2000

Prepared by
Southwest Division, Naval Facilities Engineering Command
BRAC Program Office
1230 Columbia Street, Suite 870
San Diego, CA

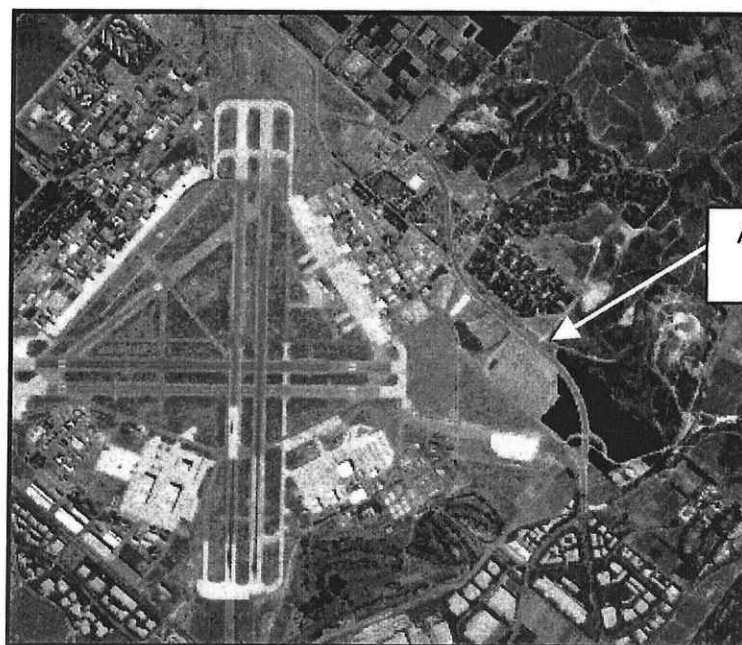
APHO 44
Vicinity

Photograph 5. APHO 44 (SAIC 288 (1974 Photograph)) Vicinity.
Disturbed Ground, Mounded Material, and Probable Trench
Aerial Photograph Anomaly Program
Marine Corps Air Station, El Toro

Current Site Conditions: *APHO 44 (SAIC 288) is located west of IRP Site 17 and adjacent to Quarry Road. The area is relatively level and grasses and weeds cover much of the surface area. Scattered construction debris items were observed on the ground surface. There are several large shrubs near the southern boundary of the anomaly investigation area.*

Is there visual evidence of the anomalies identified in the photograph present at the site? *No areas of disturbed ground or trenches were observed, however, the stockpile of clean soil located near the southeastern section of the investigation area could be considered mounded material.*

Recommendation: *No Further Action Status*

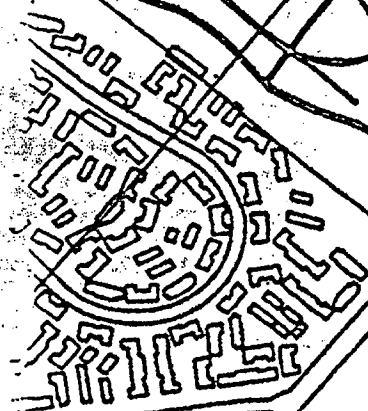
★ APHO 44 (SAIC 288) VICINITY

→ c 288. Disturbed ground (DG), mounded material (MM) and probable trench (TR) can be seen about 700 feet southeast of the Perimeter Road and Quarry Road intersection. The purpose of the features is unknown, and investigation of site history as a possible disposal area is recommended.
